SUBJ: RCRA Compliance Evaluation Inspection
Chemical Waste Management
EPA ID# ALD000622464

RCRA Inspection Report

ADEM Hazardous Waste Permit Number ALD000622464

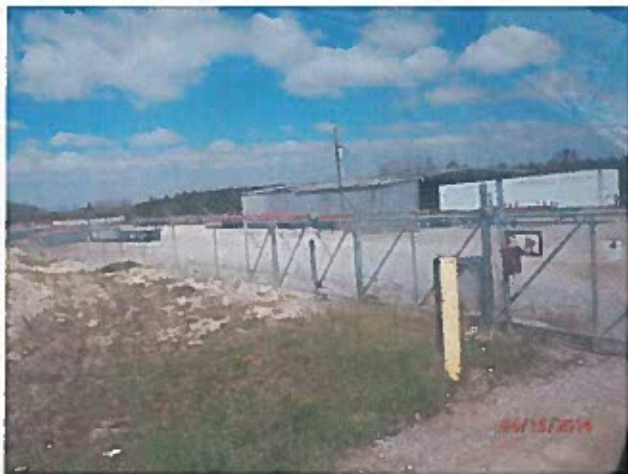
Picture 1 – Robbie D Wood 10-Day Storage Yard

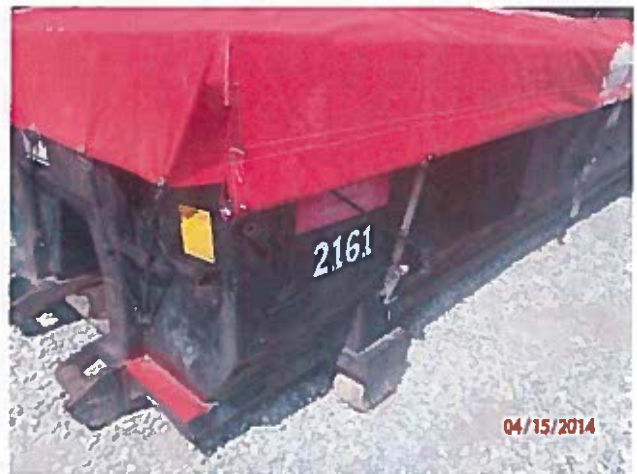
Picture 4 – RDW 10-Day Storage Yard roll-off

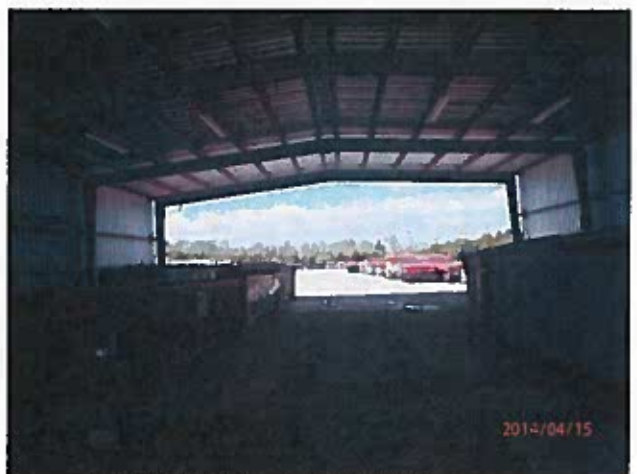
Picture 5 – RDW 10-Day Storage Yard hangar

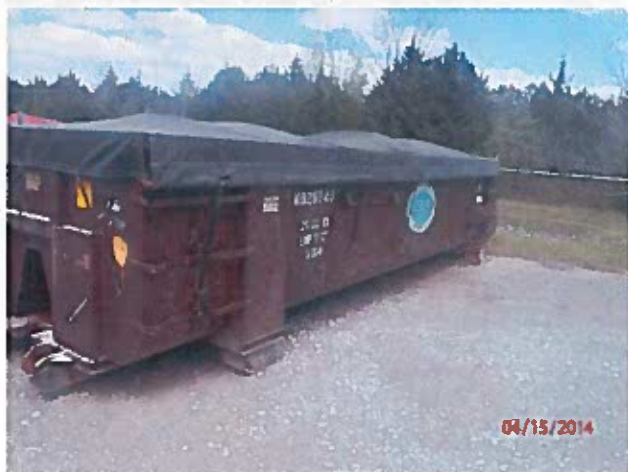
Picture 3 – RDW 10-Day Storage Yard roll-off

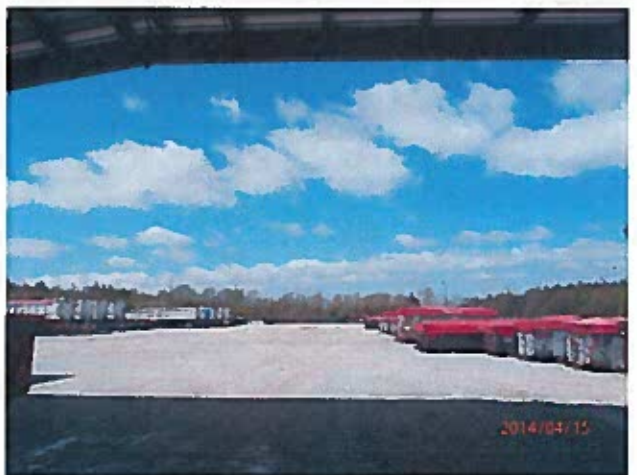
Picture 6 – RDW 10-Day Storage Yard roll-offs

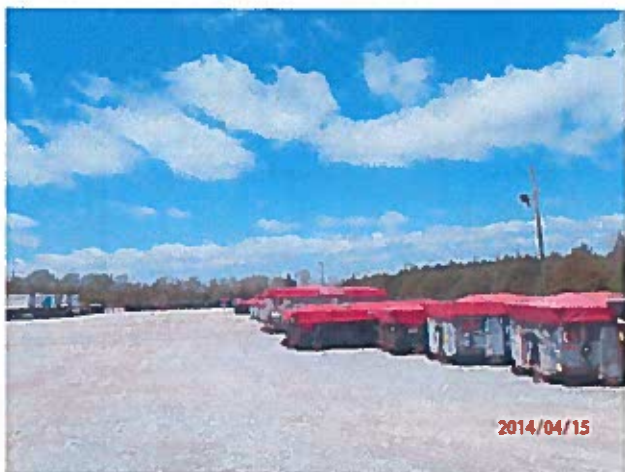
Picture 8 – RDW 10-Day Storage Yard roll-off

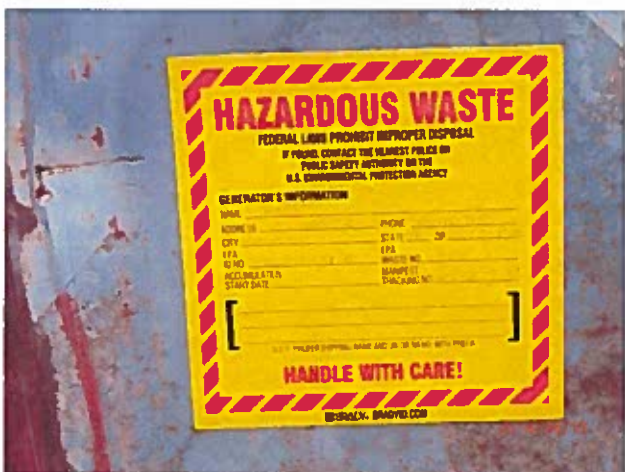
Picture 9 – RDW 10-Day Storage Yard roll-off label

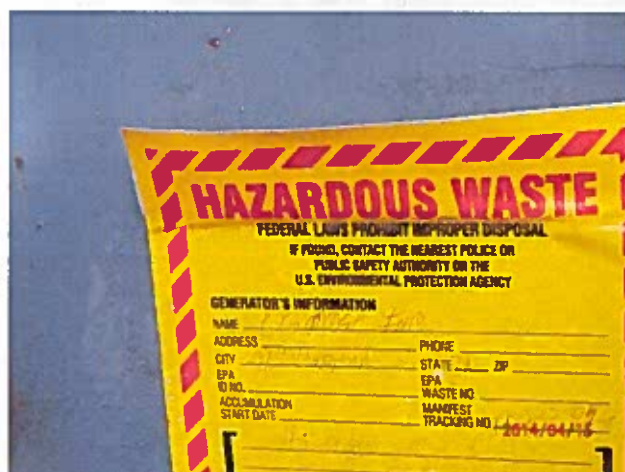
Picture 12 – RDW 10-Day Storage Yard roll-off label

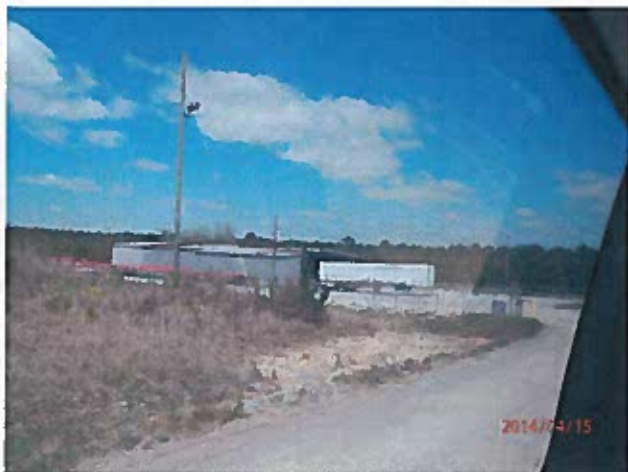
Picture 13 - Robbie D Wood 10-Day Storage Yard

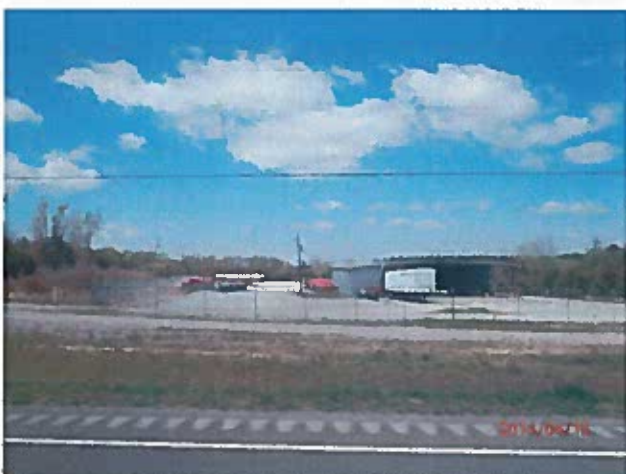
Picture 14 - Robbie D Wood 10-Day Storage Yard

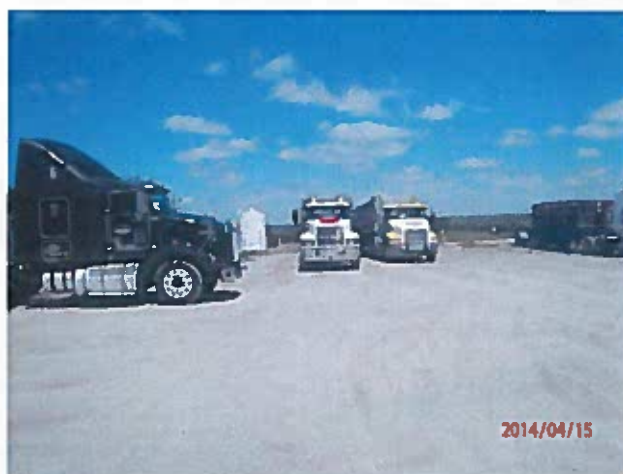
Picture 17 - PK100 Bulk Sampling Area trucks idling

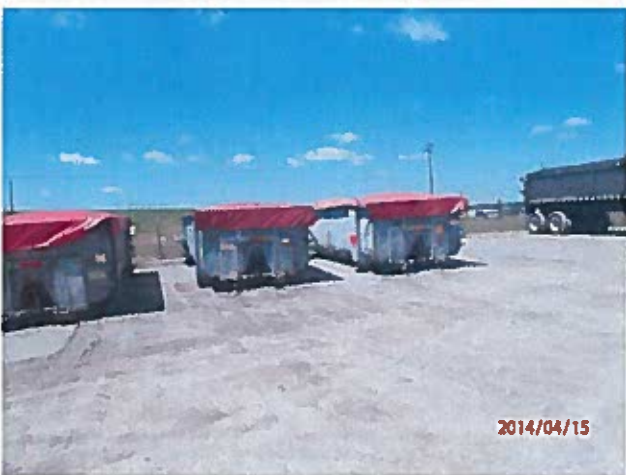
Picture 15 - PK100 Bulk Sampling Area

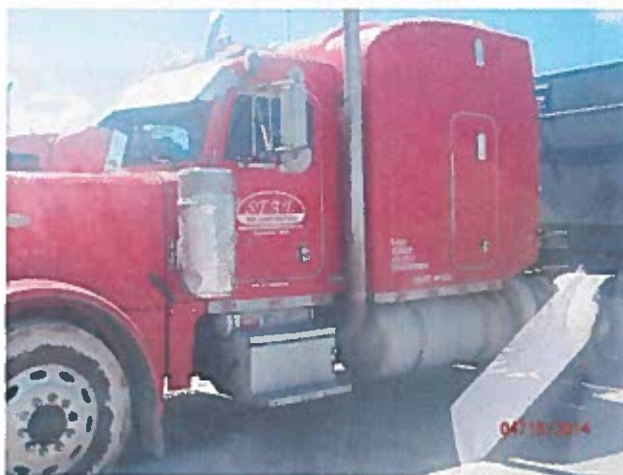
Picture 18 - PK100 Bulk Sampling Area truck idling

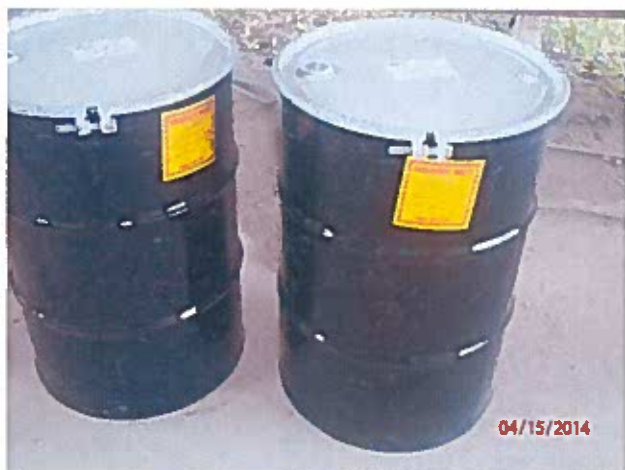
Picture 19 – PK100 Bulk Sampling Area new wash/rinse drums

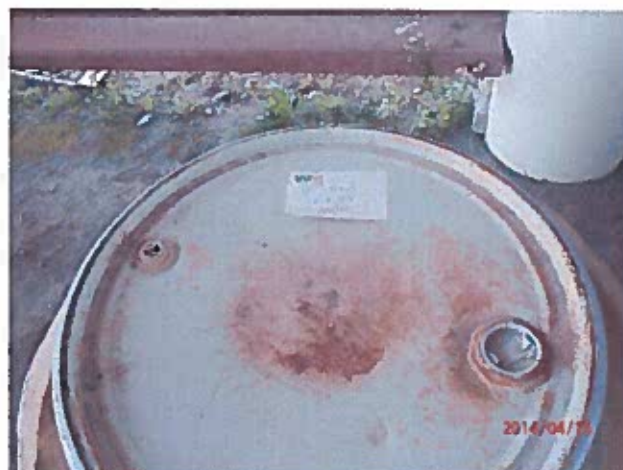
Picture 22 – PK100 Bulk Sampling Area used wash drum label

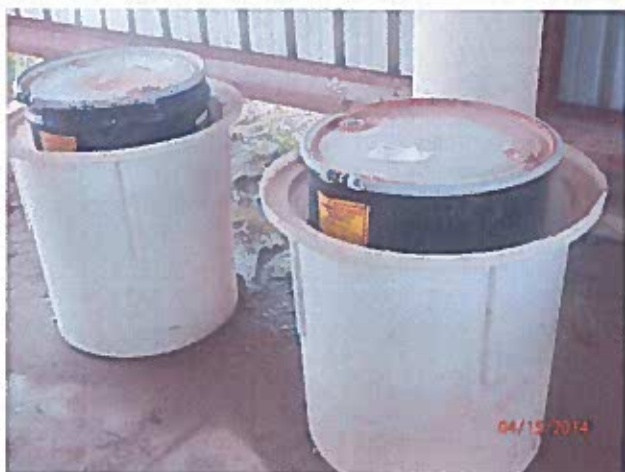
Picture 20 – PK100 Bulk Sampling Area used wash/rinse drums

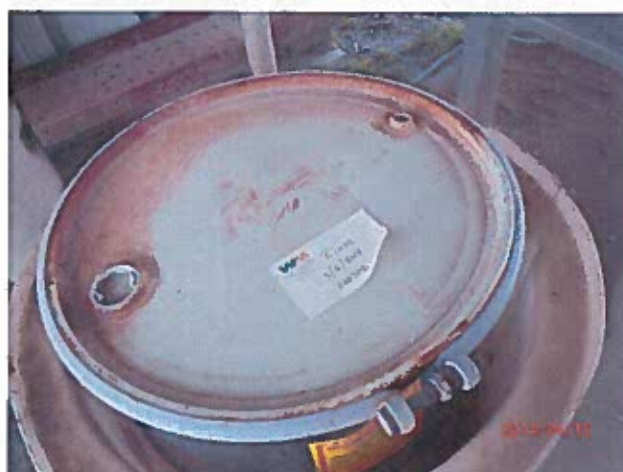
Picture 23 – PK100 Bulk Sampling Area used rinse drum label

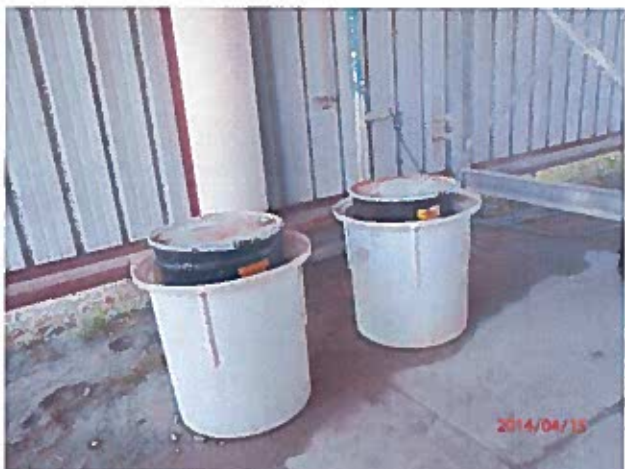
Picture 21 – PK100 Bulk Sampling Area used wash/rinse drums

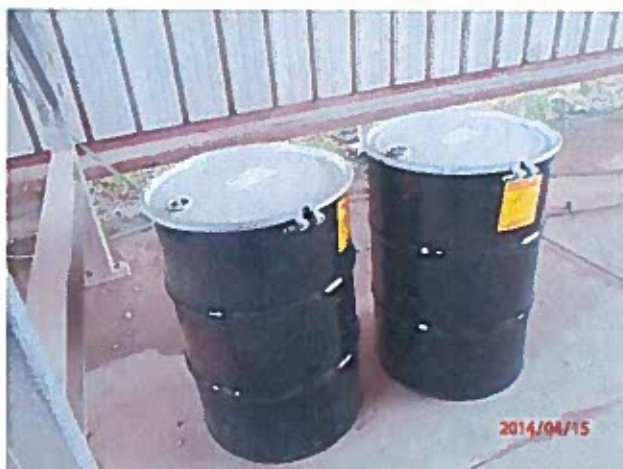
Picture 24 – PK100 Bulk Sampling Area new wash/rinse drums

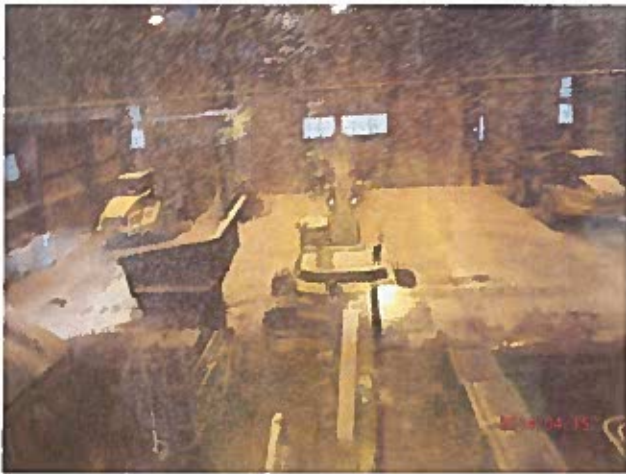
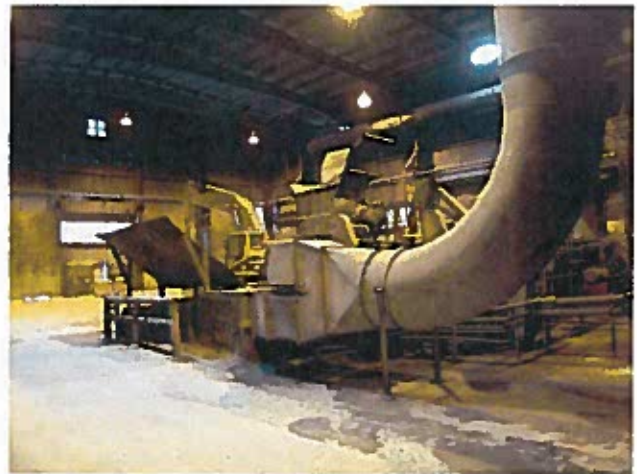
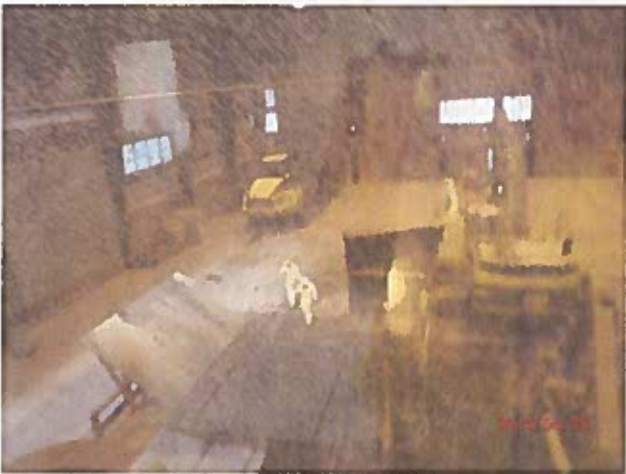
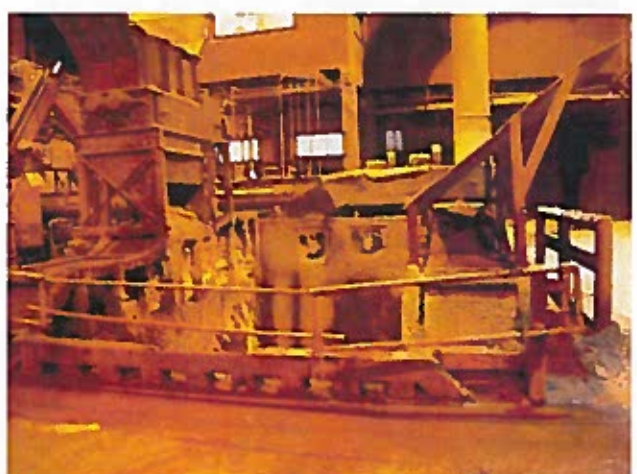
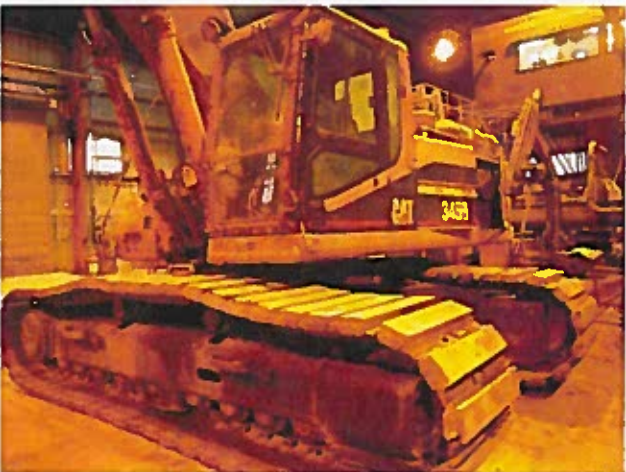
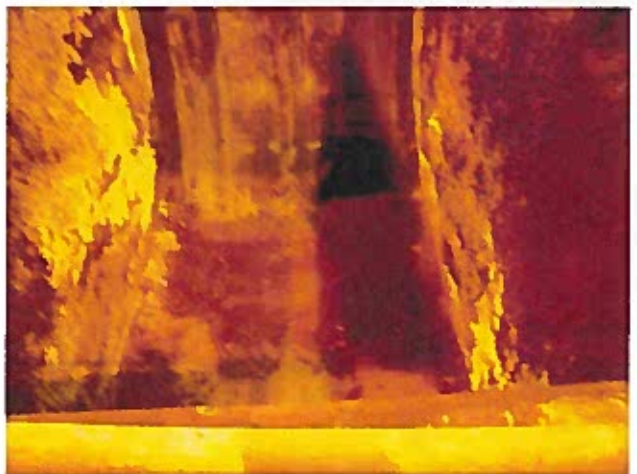
Picture 25 – Stabilization Building 1200A

Picture 28 – Stabilization Building 1200A

Picture 26 – Stabilization Building 1200A

Picture 29 – Stabilization Building 1200A

Picture 27 – Stabilization Building 1200A

Picture 30 – Stabilization Building 1200A

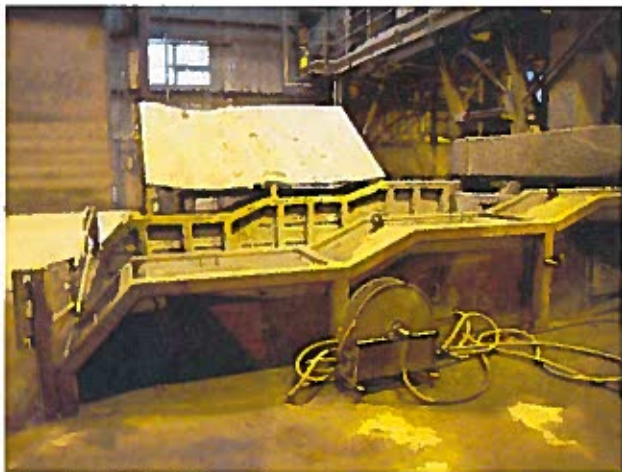
Picture 31 – Stabilization Building 1200A

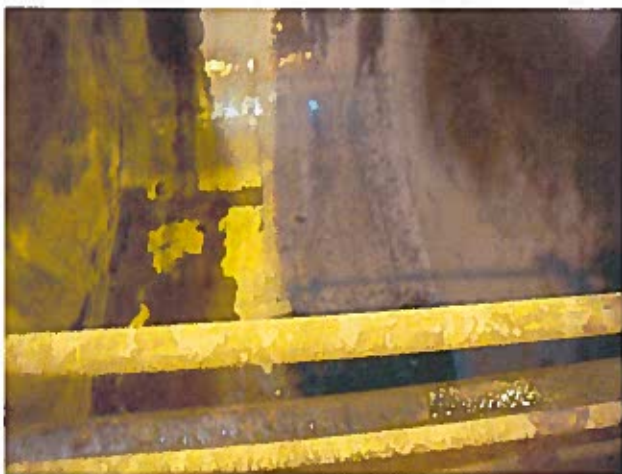
Picture 32 – Stabilization Building 1200A

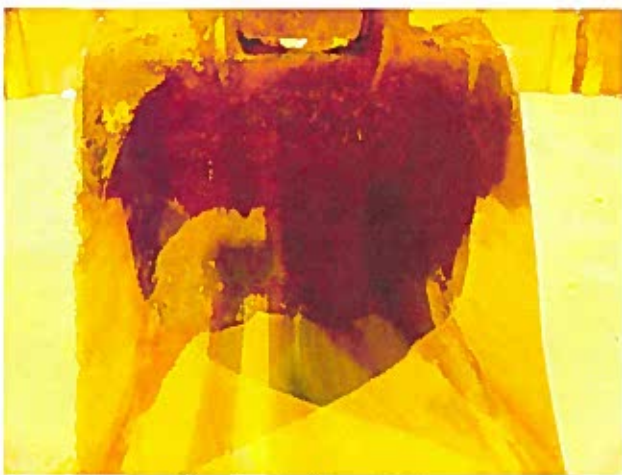
Picture 33 – Stabilization Building 1200A

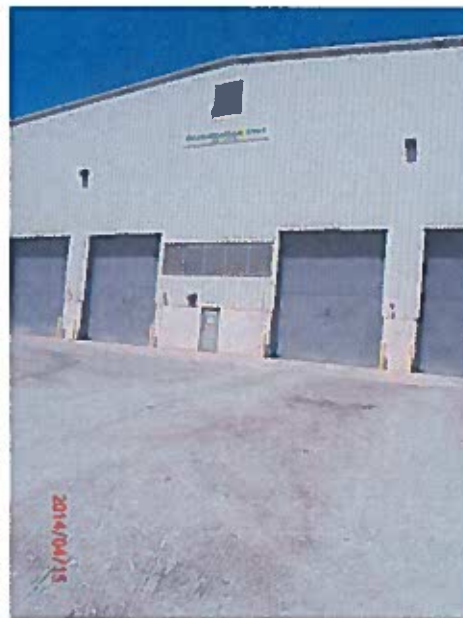
Picture 34 – Stabilization Building 1200A

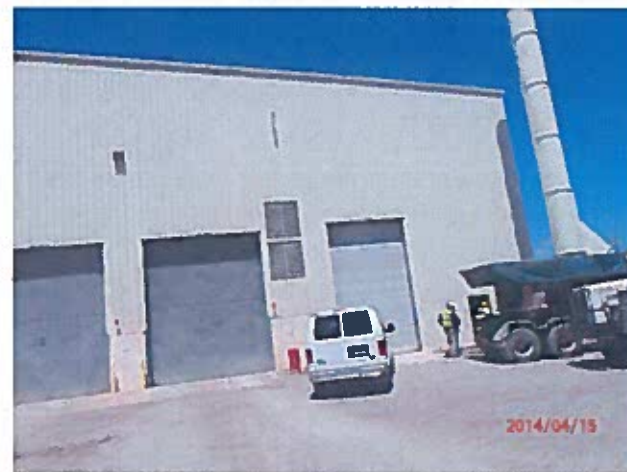
Picture 35 – Stabilization Building 1200A Silo#2

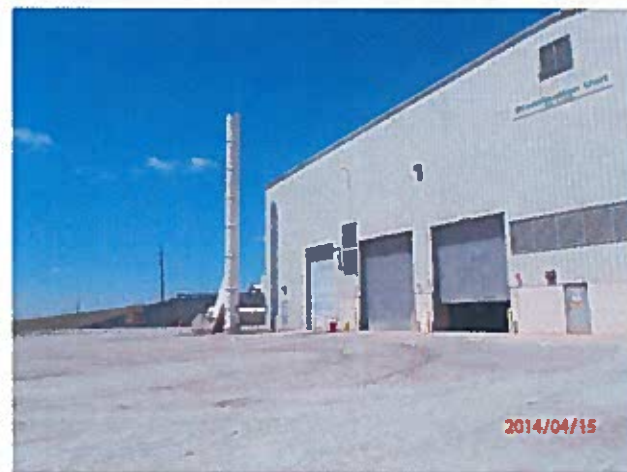
Picture 36 – Stabilization Building 1200A Silo#1

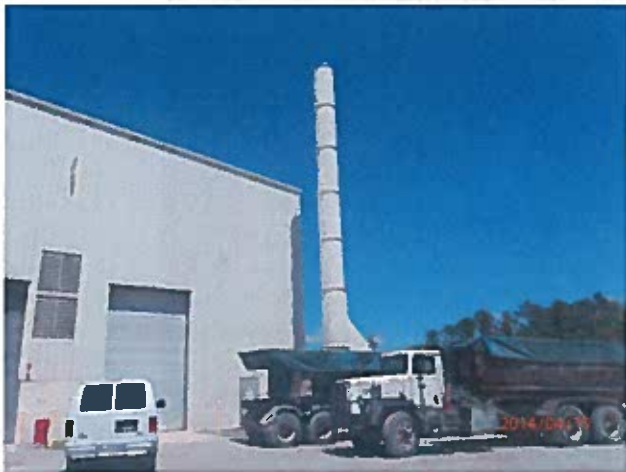
Picture 37 – Stabilization Building 1200A Silo#2

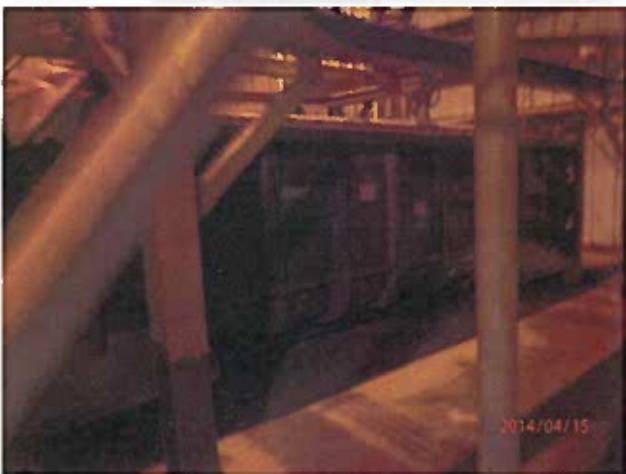
Picture 38 – Stabilization Dust Control Silo#2 roll-off

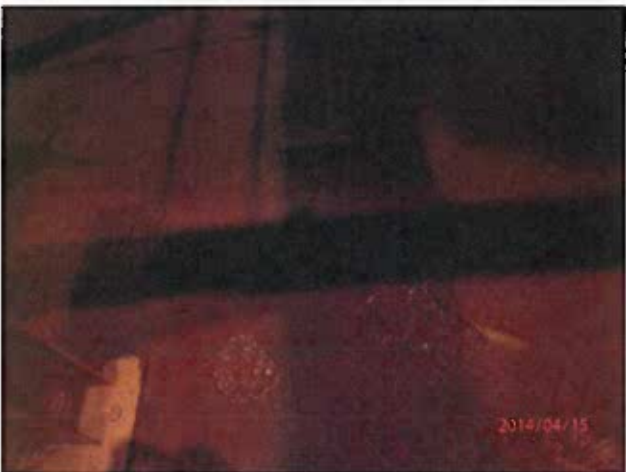
Picture 39 – Stabilization Dust Control Silo#2 dust mud

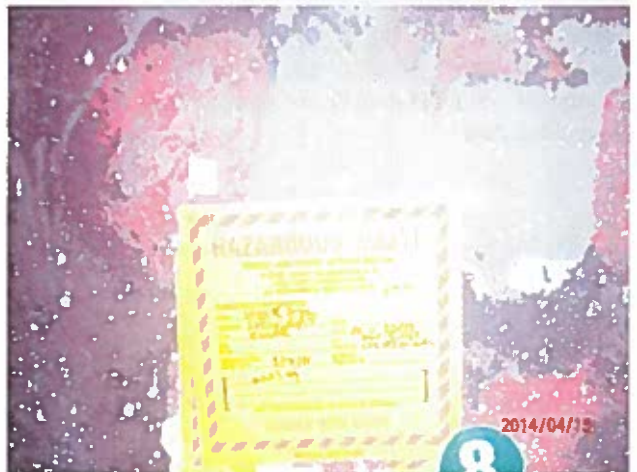
Picture 42 – Stabilization Dust Control Silo#2 roll-off label

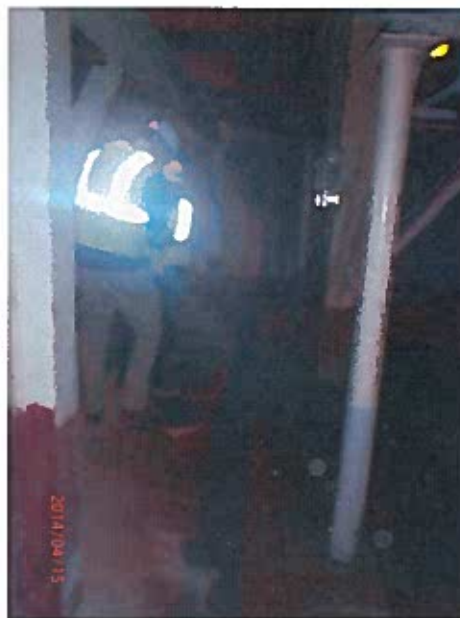
Picture 45 – Stabilization Dust Control Silo#1 floor covered in dust and water

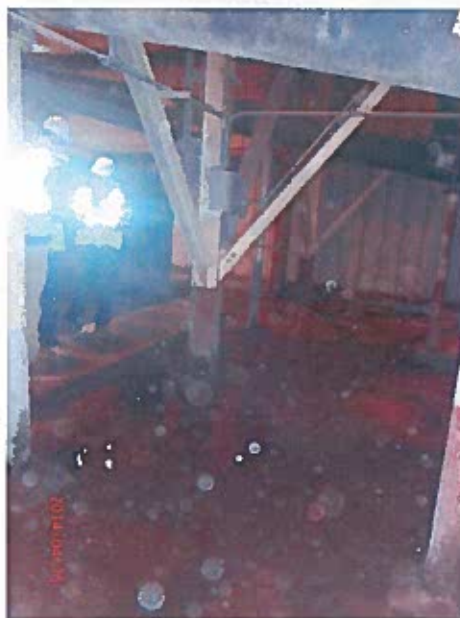
Picture 46 – Stabilization Dust Control Silo#1 floor covered in dust and water

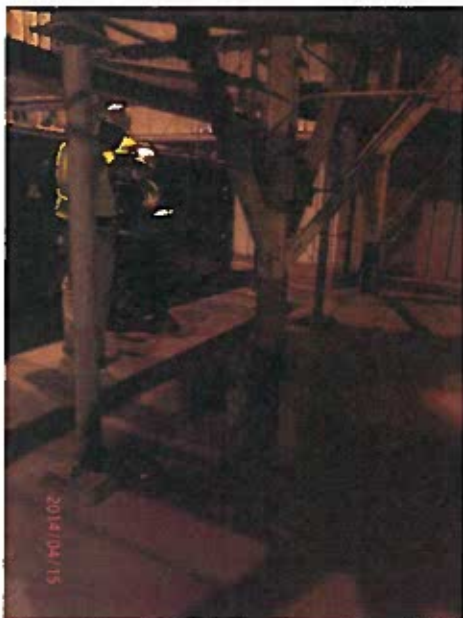
Picture 47 – Stabilization Dust Control Silo#1 floor covered in dust and water

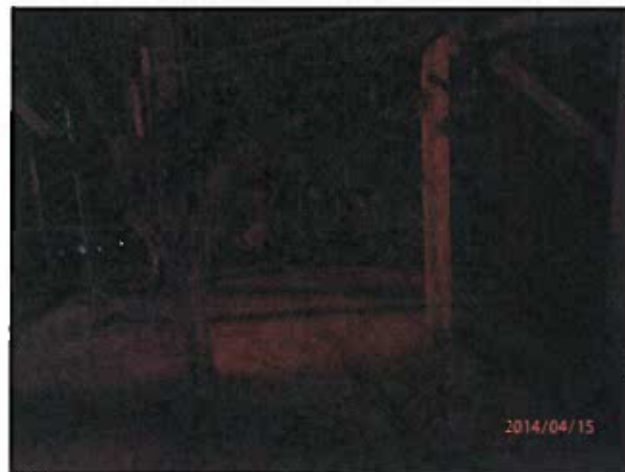
Picture 49 – Stabilization Dust Control Silo#1 floor covered in dust

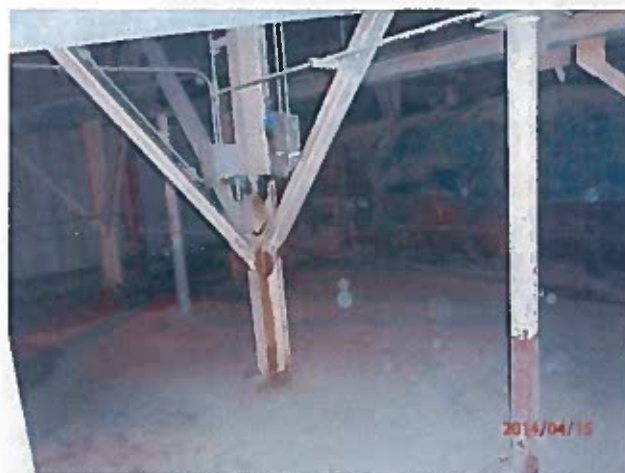
Picture 50 – Stabilization Dust Control Silo#1 floor covered in dust

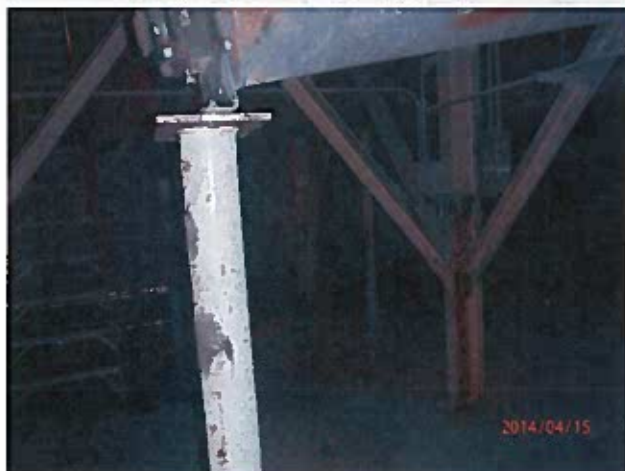
Picture 51 – Stabilization Dust Control Silo#1 floor covered in dust

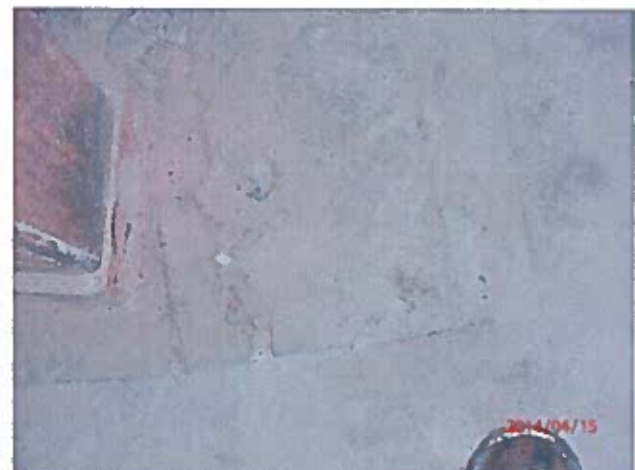
Picture 55 – Stabilization Dust Control Silo#1 steel footing covered in dust

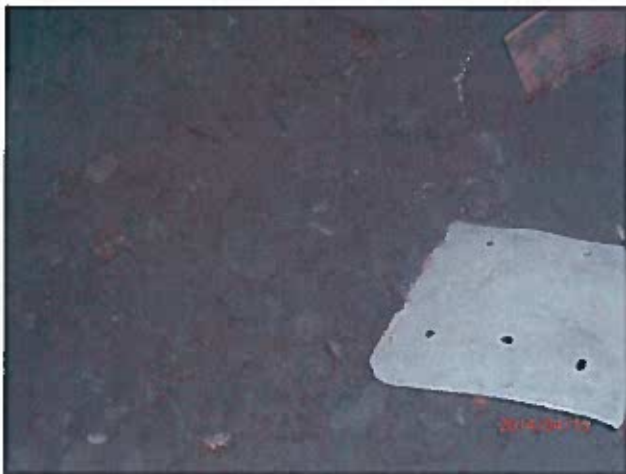
Picture 56 – Stabilization Dust Control Silo#1 floor covered in dust

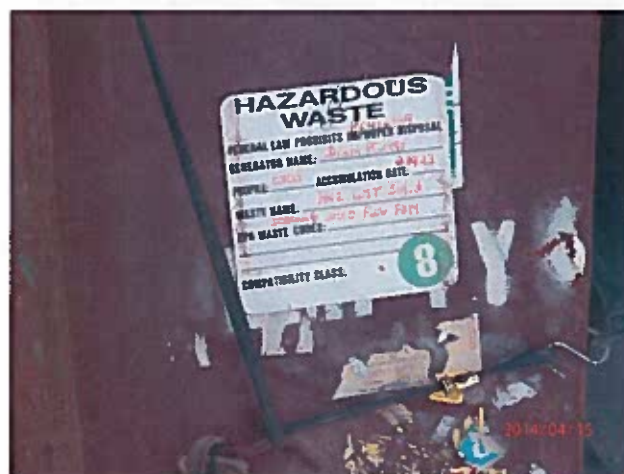
Picture 72 – Building 2200 Container Storage roll-off label with wrong date

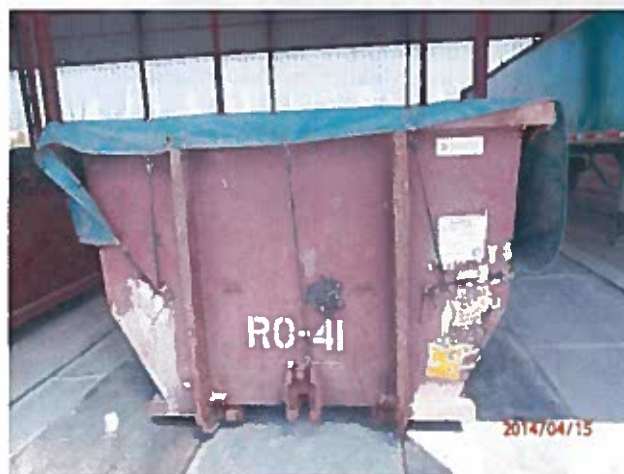
Picture 73 – Building 2200 Container Storage roll-off label with wrong date

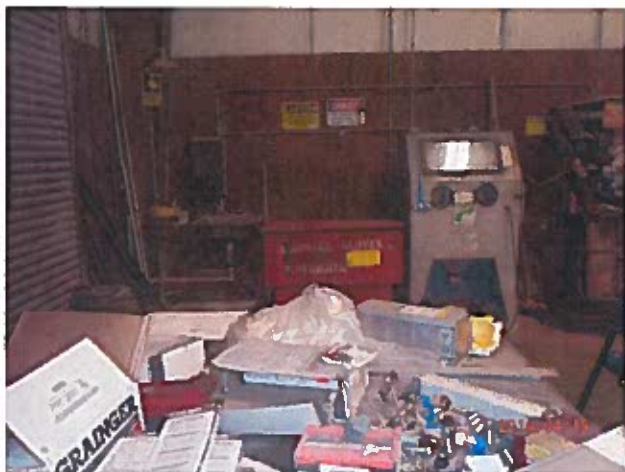
The facility maintenance is managed by Mr. Bill Young. Facility Maintenance houses the electricians and welders. The inspectors observed a parts washer (Picture 74), which is serviced by Safety Kleen, and located in the rear of the building. Next to the parts washer is a sand blaster that uses medium glass bead blast media (Picture 75). The spent blast media profile EMS 000302 has been determined by CWM Emelle to be non-hazardous. Outside rear of the building is a 35-gallon red flammable flip-top can used to collect empty aerosol cans (Pictures 76-77). The can was closed and labeled. No hazardous waste was observed inside the building.

Picture 74 – Facility Maintenance Building 606

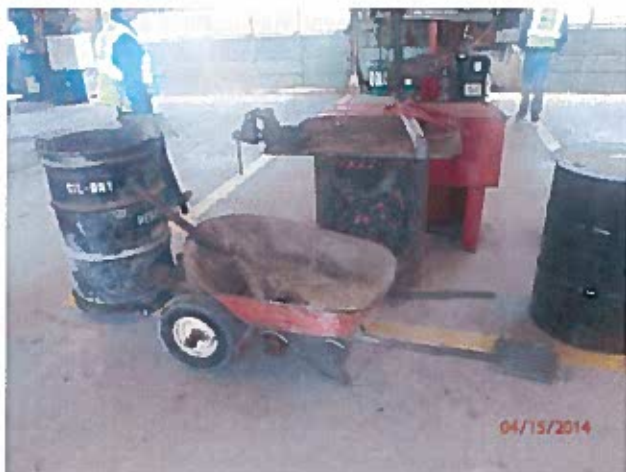
Picture 78- Heavy Equipment Maintenance oil dry clean up

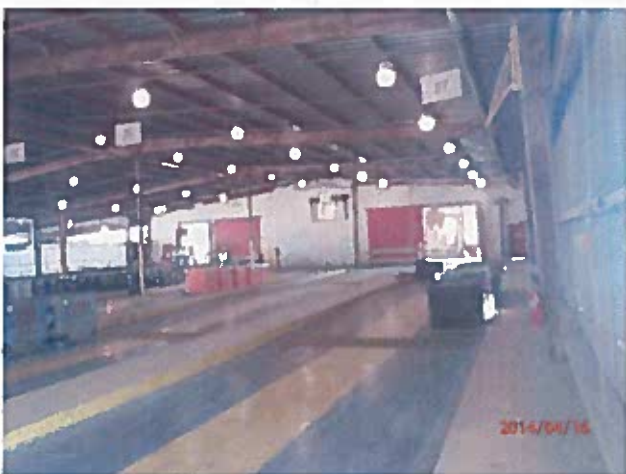
Building 700 also contained Dump 03 roll-off for non-hazardous waste that goes to the landfill (Picture 98); cement kiln dust that is brought in as product and used as filler in the drums; and an intake loading dock with two hazardous waste roll-offs (Pictures 99-102, 105). The black covered roll-off was from drum processing and was going to macro encapsulation. The red covered roll-off was from drum processing and was going to incineration. The roll-offs were closed and labeled.

Picture 99 – Building 700 Intake Loading Dock

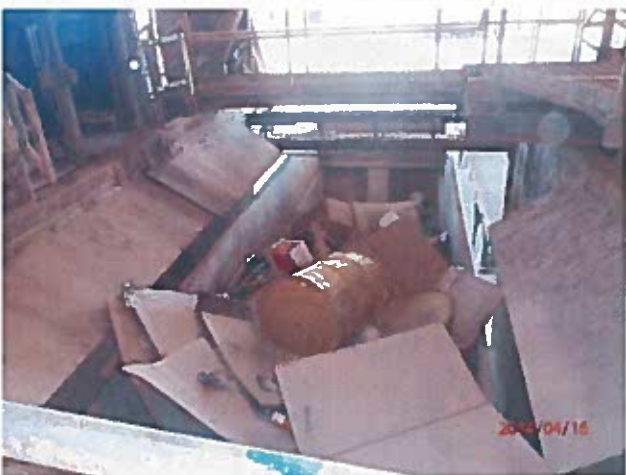
Picture 100 – Building 700 Intake Loading Dock

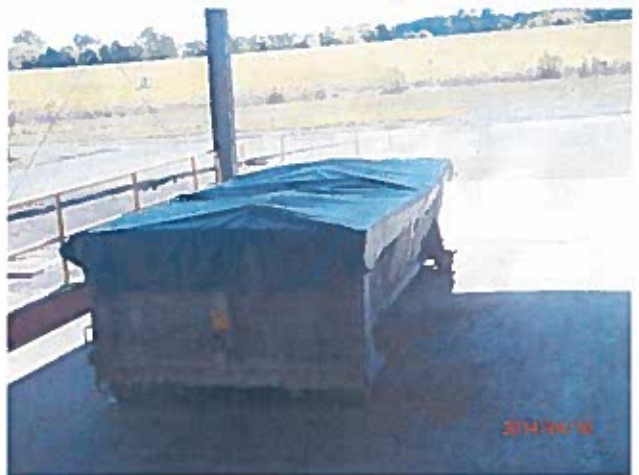
Picture 98 – Building 700 Dump 03 Roll-off

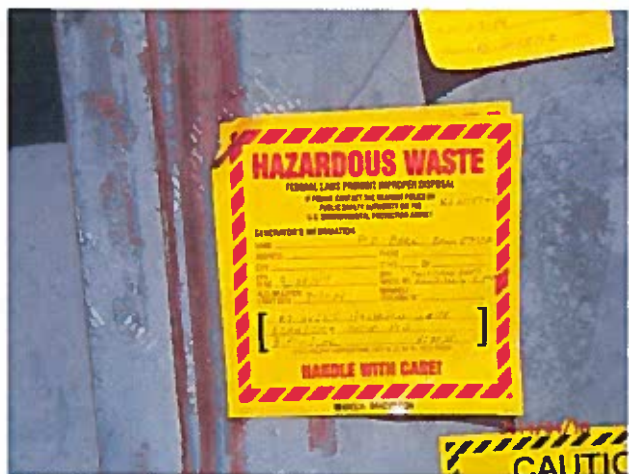
Picture 101 – Building 700 Intake Loading Dock

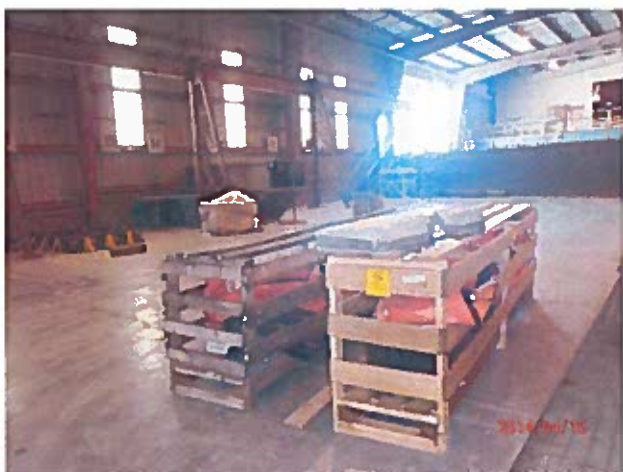
Picture 124 – Building 600 TSCA Storage

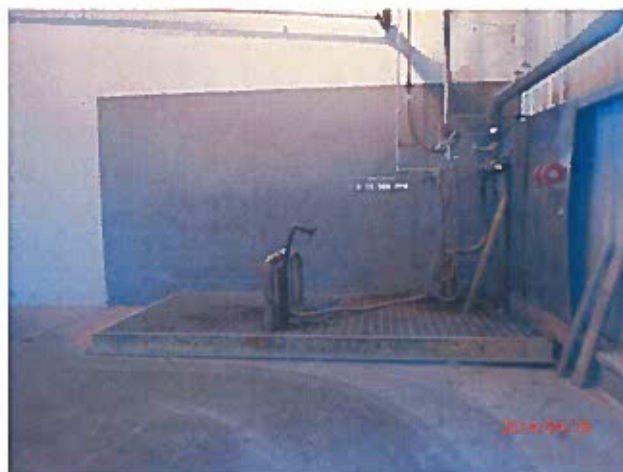
Picture 125 – Building 600 TSCA Storage

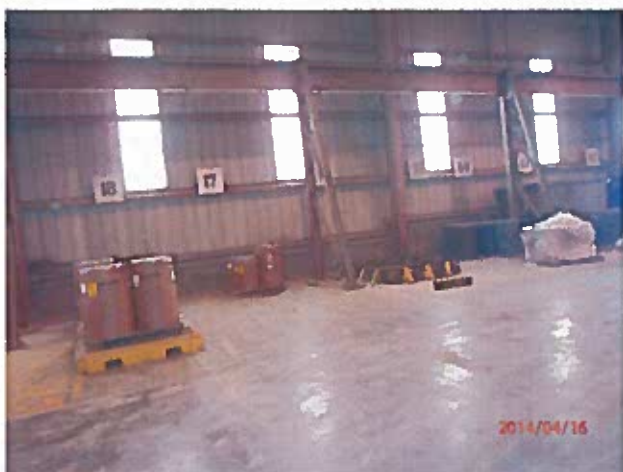
Picture 128 – Building 600 TSCA Storage organic waste pit

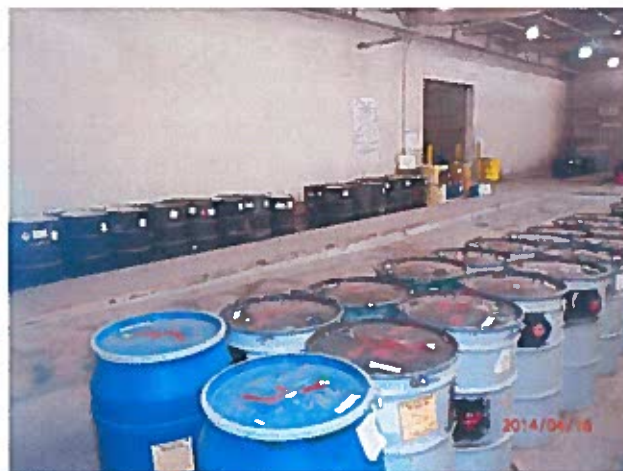
Picture 127 – Building 600 TSCA Storage organic waste pit

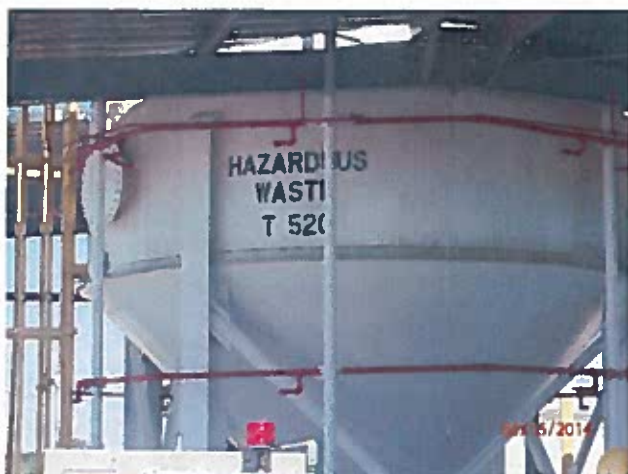
Picture 142 – Building 520 Hazardous Waste Tank

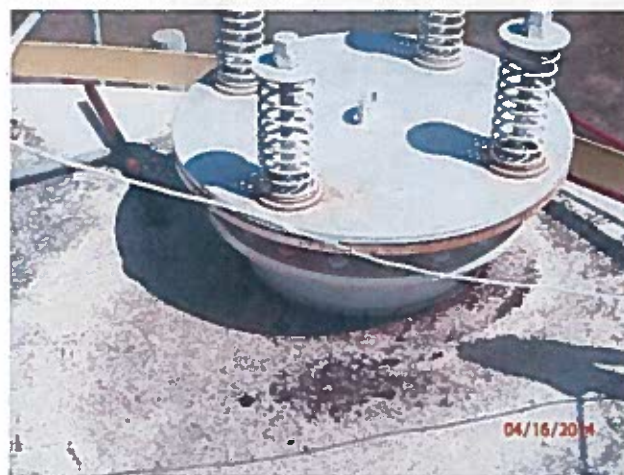
Picture 143 – Building 520 Hazardous Waste Tank

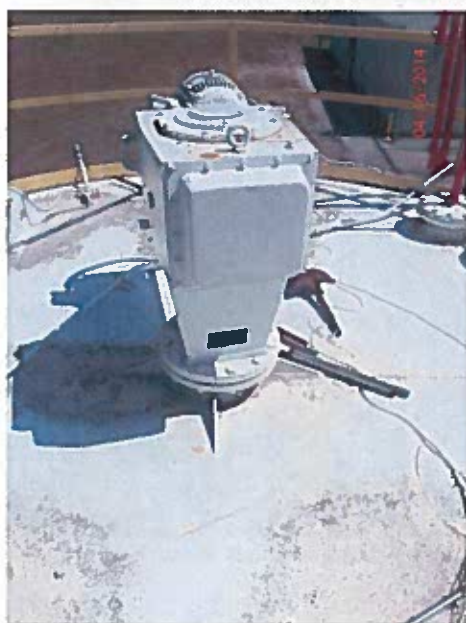
Picture 147– Building 520 Hazardous Waste Tank connections

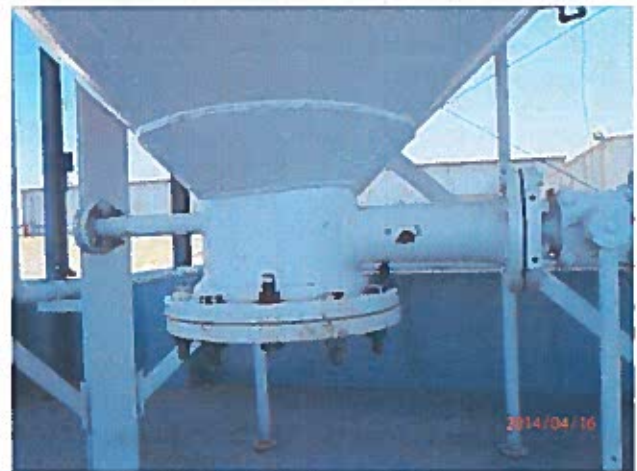
Picture 150 – Building 520 Hazardous Waste Tank BB tags

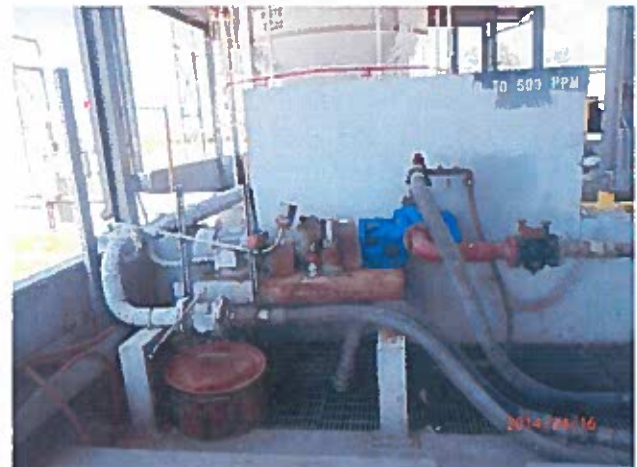
Picture 151 – Building 520 Hazardous Waste Tank flanges

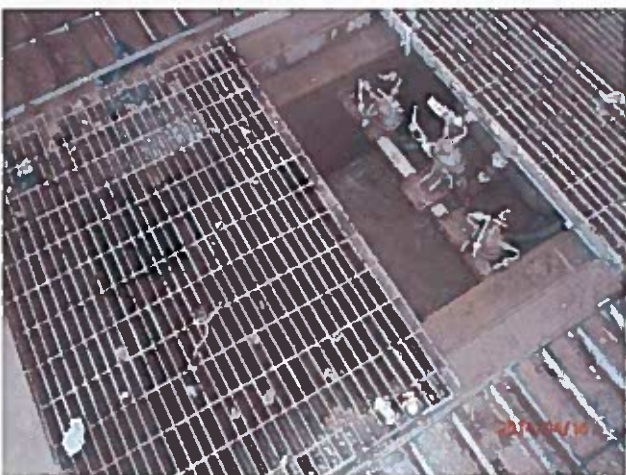
Picture 169 – Hazardous Waste Landfill Trench 22

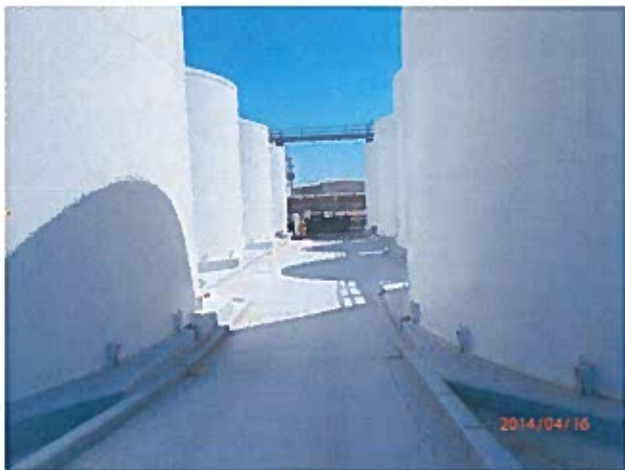
Picture 194 – Tank Farm floor epoxy peeling

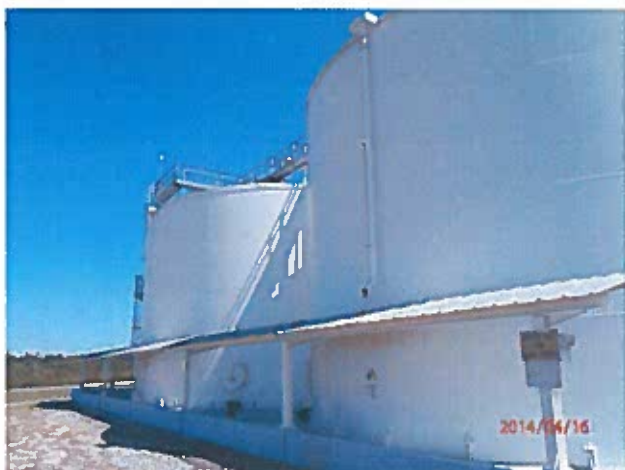
Picture 198 – Tank Farm tank peeling

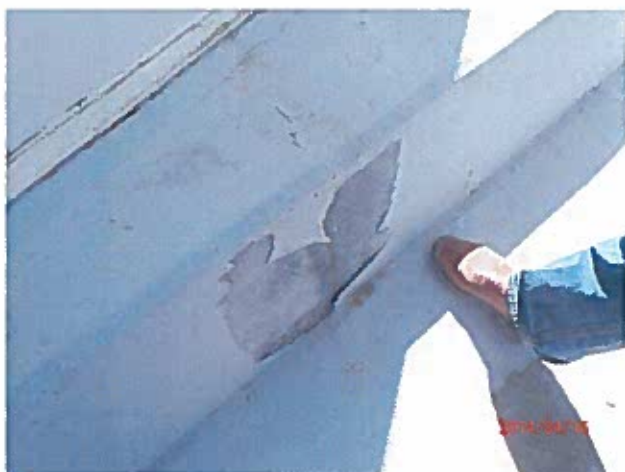
Picture 199 – Tank Farm tank peeling

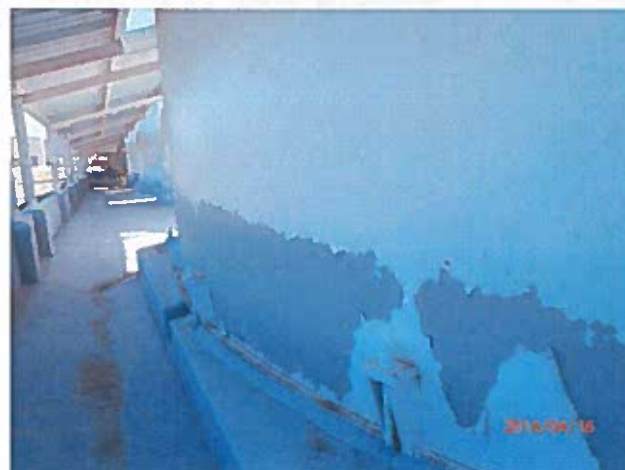
Picture 197 – Tank Farm tank peeling
